Project: Village Hall Roof Assessments

Inspector: Ron Dorszynski
Date: 10/10/18 and 11/19/2018
Others Present: Andy LaFond and Diane Robertson

Roof ID: Village Hall Offices

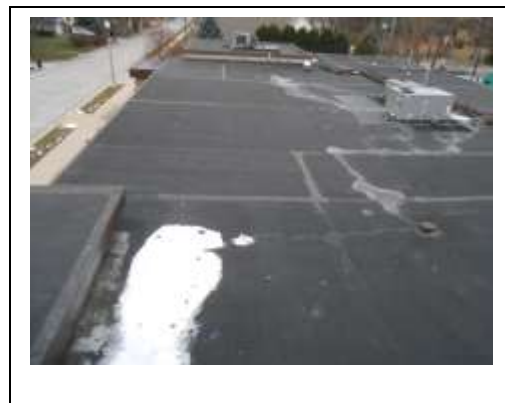
Observation #1 - This roof is in fairly-good condition and drains itself fairly-well.

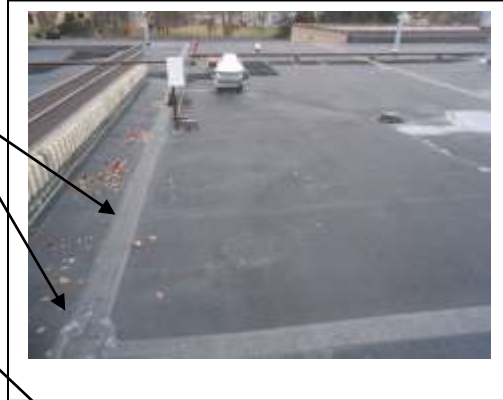
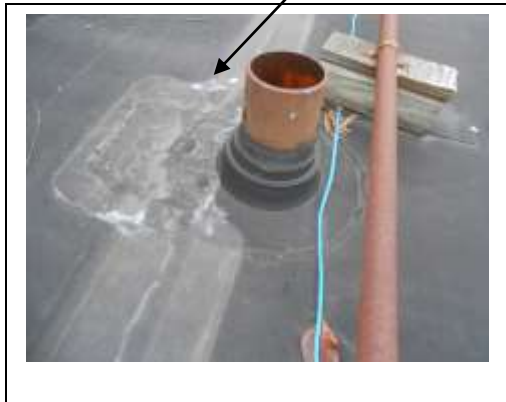
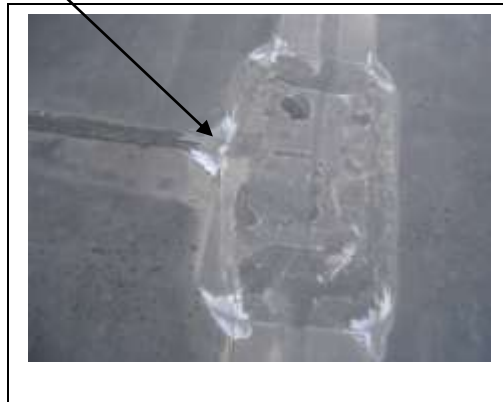
Observation #2 - Some of the field seams, T-joint covers and other flashings have been resealed with cover tape and sealant.

- Short- to Mid-term
 - o Reseal or cover any defective T-patches or cover tape flashings.
 - o Routinely clean debris from around roof drain strainers
 - o Refinish or replace roof hatch cover. Monitor flashing around hatch curb.
- Long-term
 - o Replace roof system within 10 – 12 years

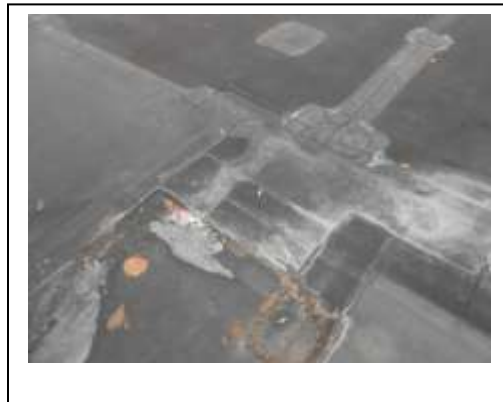
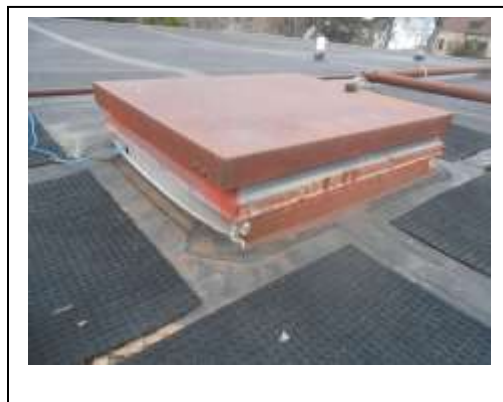
Observation #3 - Some leak patching has occurred in the field area and around the roof access hatch.

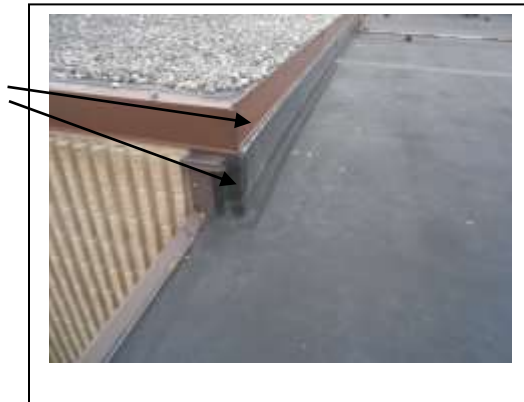
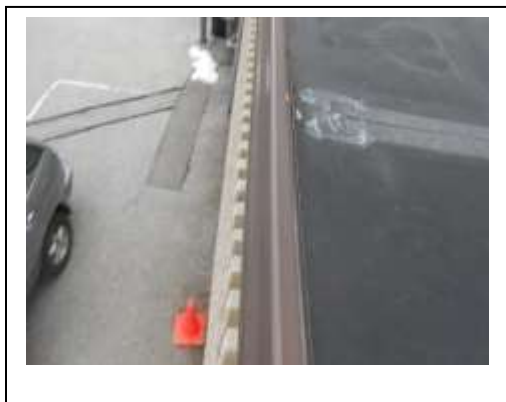
Observation #5 - Base and metal flashing components appeared fairly-sound around the roof edges.

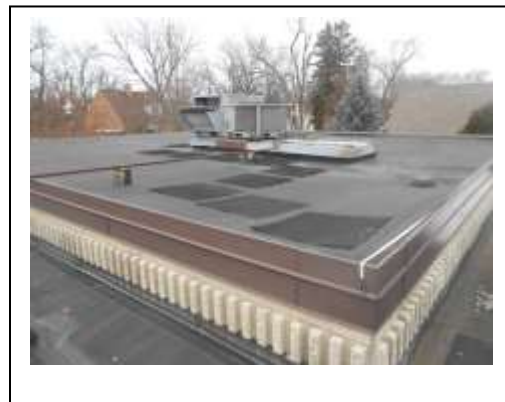
Observation #6 – This older adhered EPDM rubber roof is showing its age with spot loss of adhesion of the field membrane, defects in the flashings and leakage.

- Short-term:
 - o Reseal or cover any defective T-patches and defects on base flashings
 - o Routinely clean debris from around roof drain strainers.
 - o Monitor metal curb cap for rust-through. Seal over corroded areas to keep watertight until rooftop unit gets replaced.
- Mid-term:
 - o Replace roof system as soon as feasible.

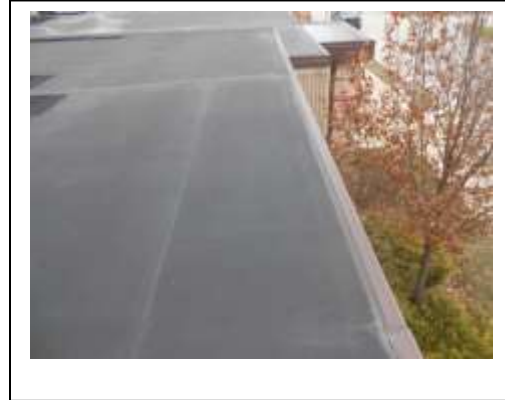
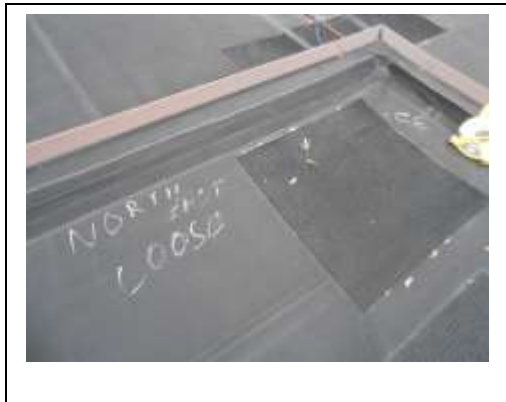
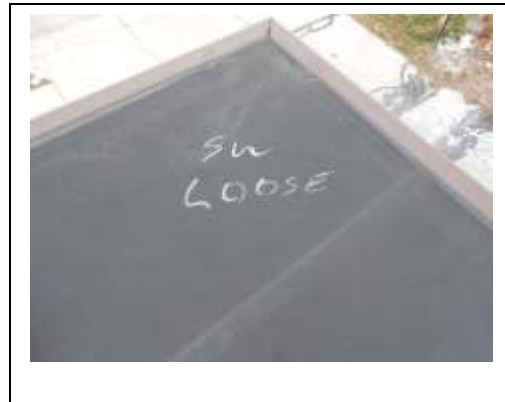
Observation #7 - The 26-year old EPDM membrane was fairly-weathered but still functioning.

Adhesion of the field membrane to the substrate was failing along the west roof edge and in the northeast corner.

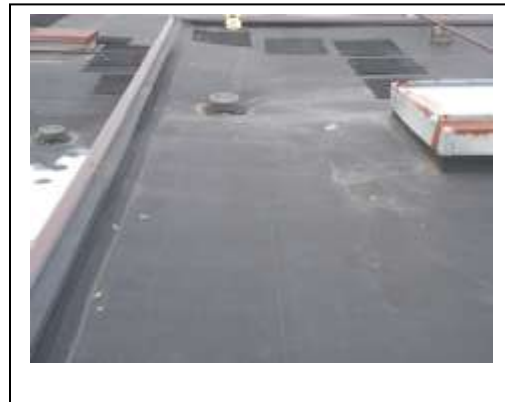
Observation #8 - The roof drained well to the roof drain.

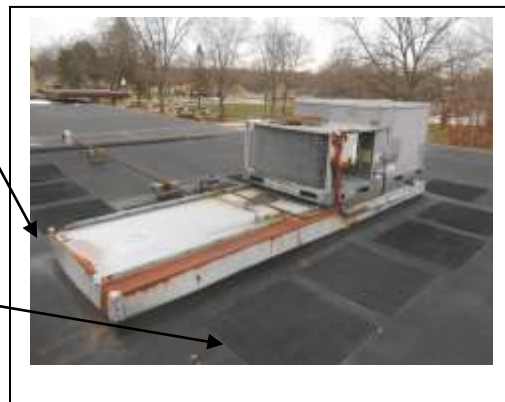
Observation #9 - Leakage appeared to originate from the north end of the rooftop unit curb and metal cap.

Rubber traffic pads protected the rubber roofing to and around the rooftop unit.

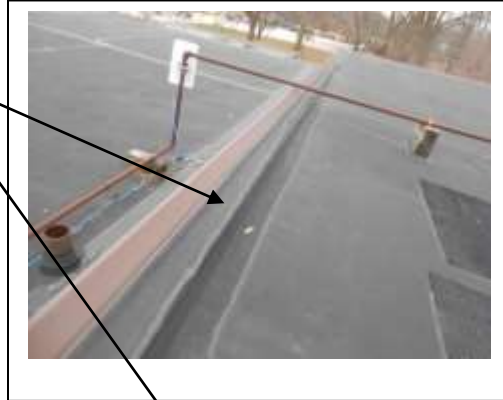
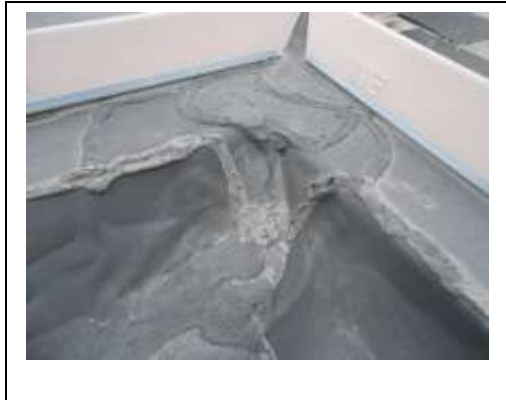
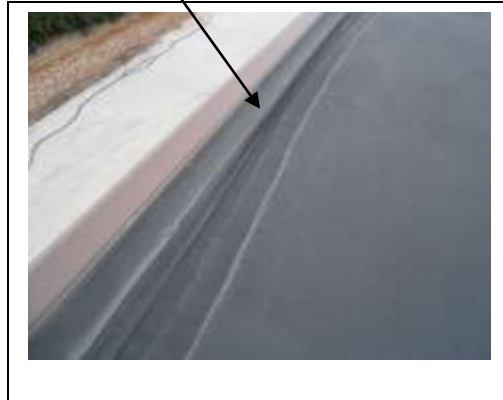
Observation #10 - The base flashing was well adhered at the perimeter edges except for of a portion of the flashing along the west edge which had sagged.

There had been some prior repairs to the corners of the roof edge flashings.

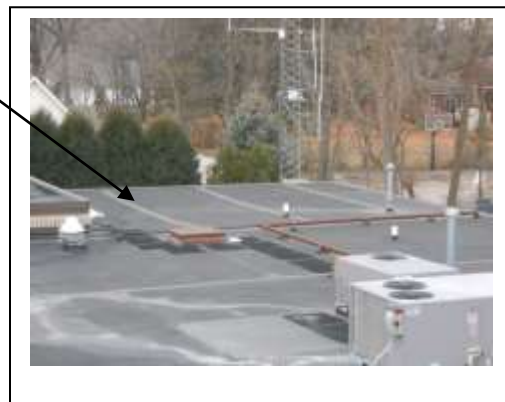
Observation #11 – No leakage was reported from this adhered rubber roof.

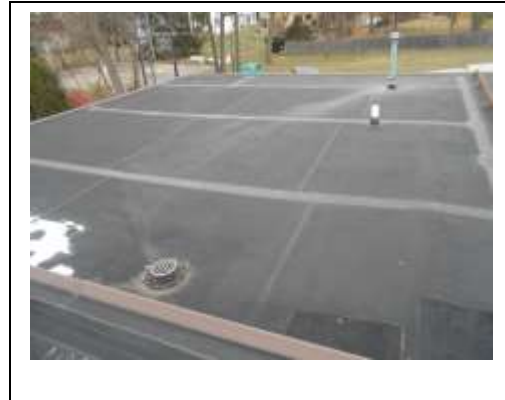
Observation #13 -Tapered insulation channeled water to the roof drain.

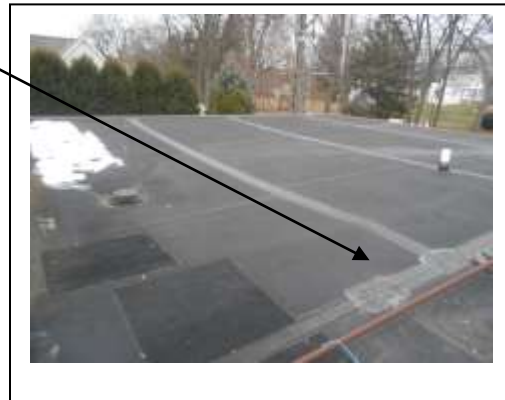
Observation #14 - Some seam and flashing repairs had already been performed.

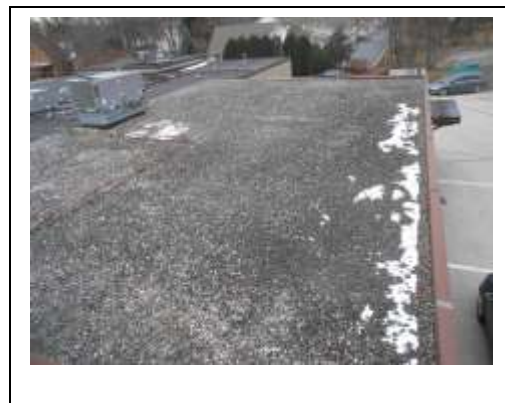
Observation #15 - The older ballasted EPDM rubber roof over the training room roof drained well.

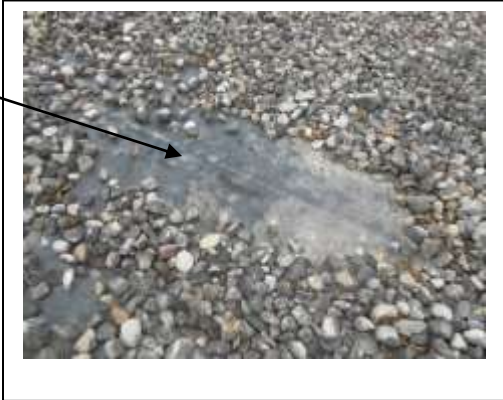
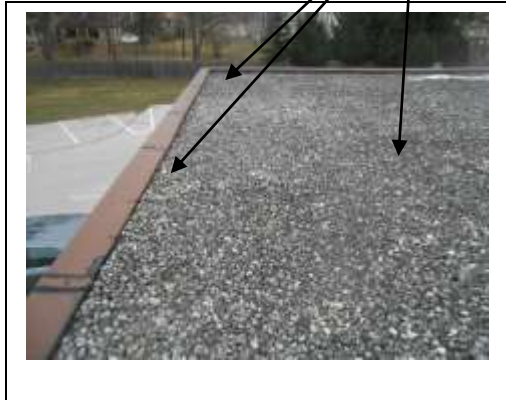
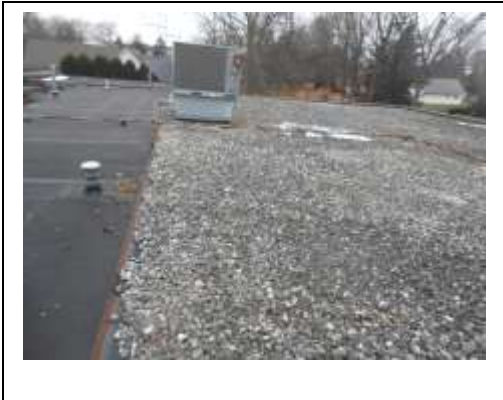
Observation #16 - No defects were noted during random checks of the field seams.

Approximately 10 – 14lbs per square foot of ballast stone anchored the loosely-laid EPDM rubber in place.

Ballast coverage in the field areas, perimeter edges and corners was good.

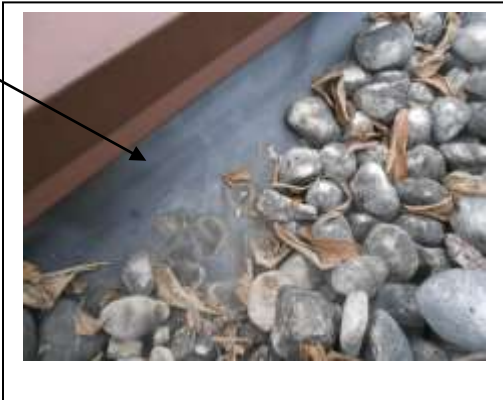
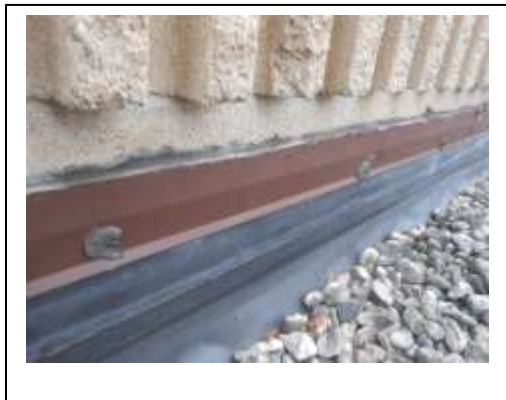
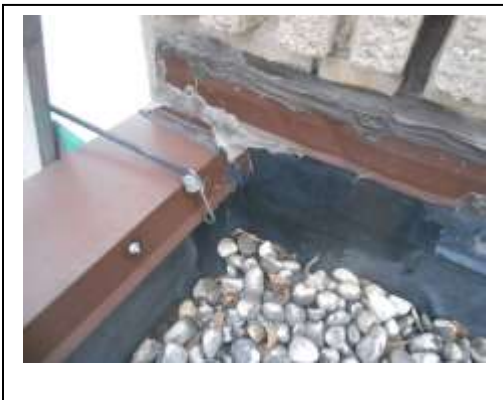
Observation #17 - The rubber base flashing at the north and west outer walls and at the adjacent North Apparatus Bay wall to the east appeared sound, though some prior patching had been performed.

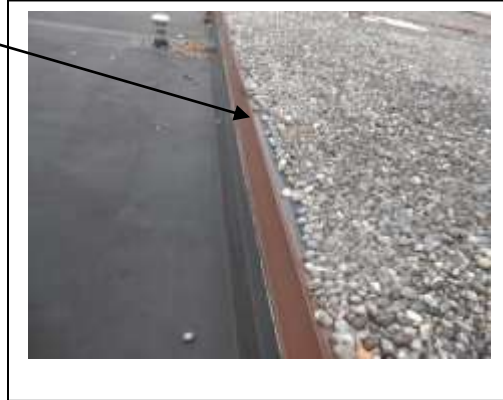
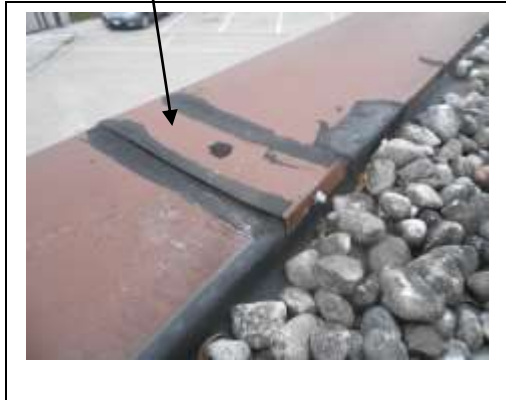
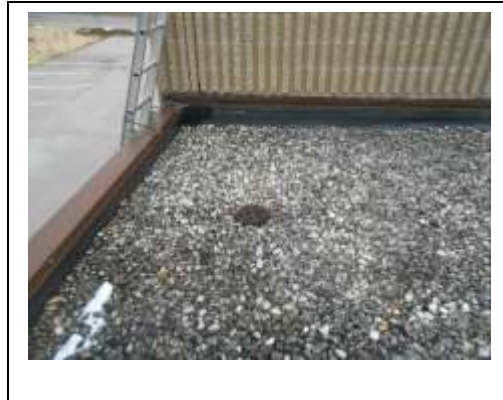
Observation #18 - The low-profile angled roof edge along the south wall, along with the east wall counter flashing and the north and west wall copings were generally sound.

There were however some portions of the copings where the joints had loosened and become possible points of water intrusion.

- Short-term:
 - o Reseal or cover any defective T-patches and defects on base flashings
 - o Routinely clean debris from around roof drain strainers.
 - o Re-anchor and seal metal coping covers.
- Mid-term:
 - o Replace roof system in the next 2 – 4 years.

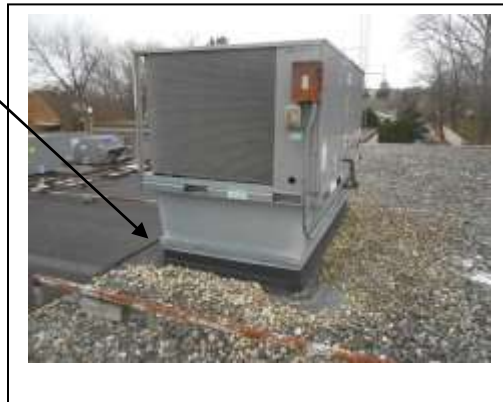
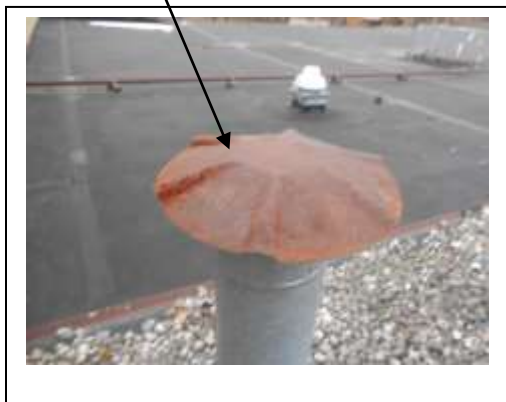
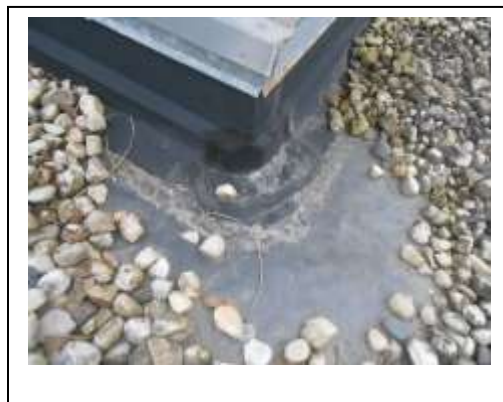
Observation #19 - The curbs and flashings at the rooftop unit appeared sound.

Some of the miscellaneous metal roof vent components were fairly-corroded.

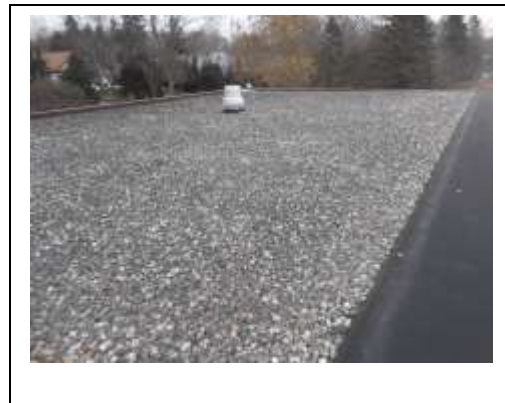
Observation #20 – The field area of this older ballasted EPDM rubber roof drained well and had been relatively watertight.

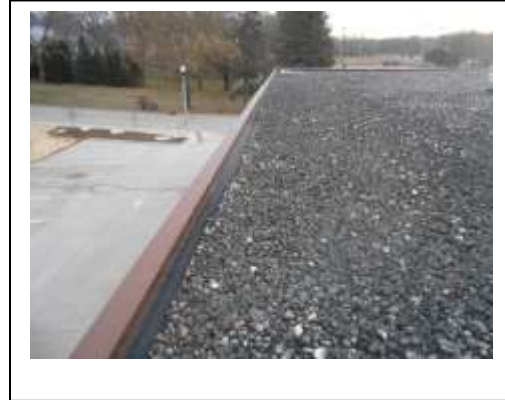
Observation #22 – Ballast coverage in the field and perimeter areas was good.

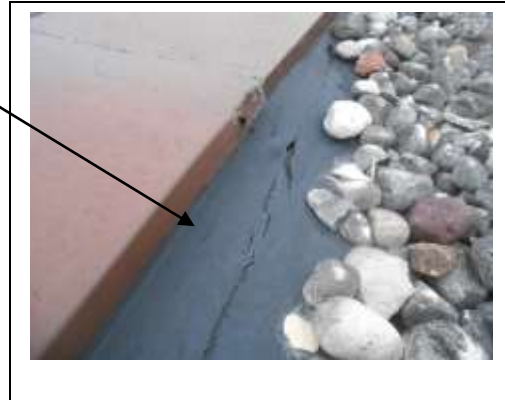
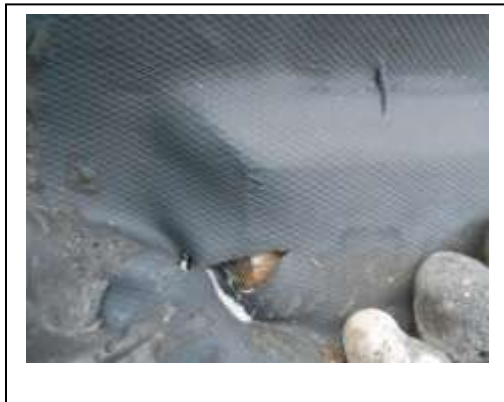
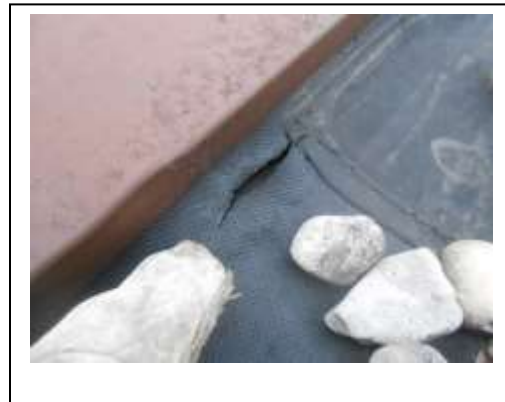
Observation #23 – The weakest part of this roof has been the perimeter flashings. The badly-weathered exposed portion of the flashings had numerous splits and holes which allowed water to enter and wet the immediate area of the defect.

- Short-term:
 - o Reseal or cover any defective T-patches and defects on base flashings.
 - o Routinely clean debris from around roof drain strainers.
 - o Re-anchor and seal metal coping covers.
- Mid-term:
 - o Replace roof system in the next 1 - 2 years.

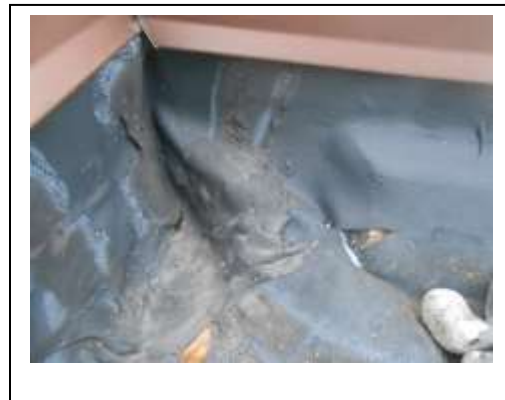
Observation #24 – The inside corners of the perimeter flashings were a bit of a mess and, like the balance of the perimeter flashings, needed additional repair to stay watertight.

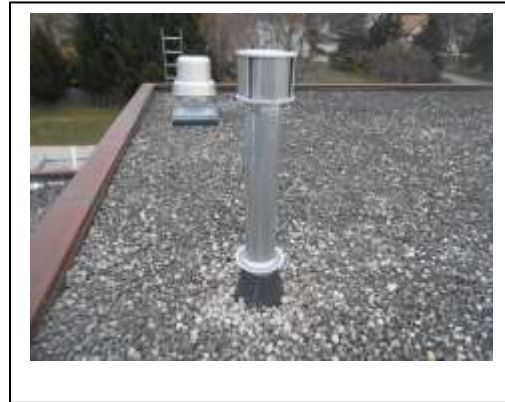
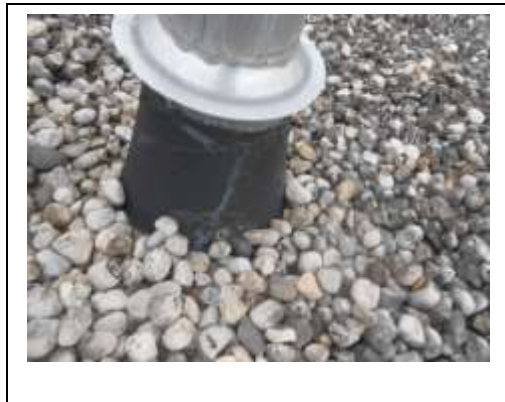
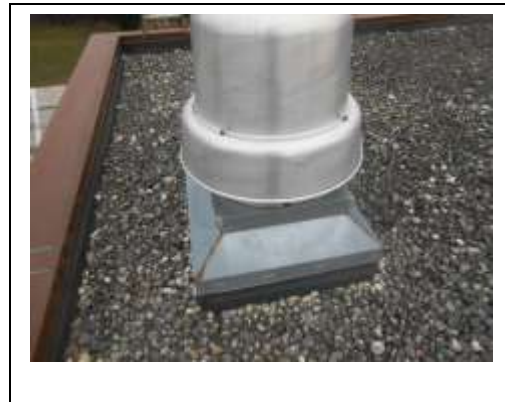
Observation #25 – The flashings on the various roof protrusions appeared sound.

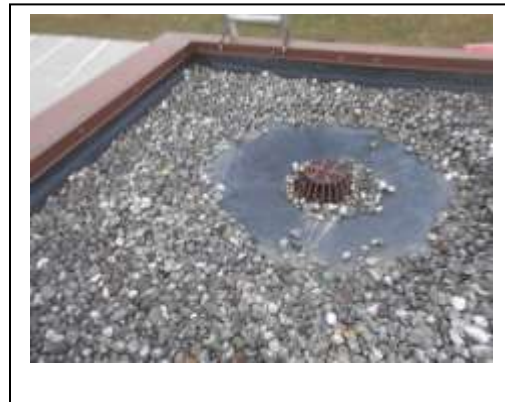
Observation #26 – Water drained well to the roof drains. The drains need to be inspected regularly so debris does not have a chance to accumulate and create ponding water conditions.

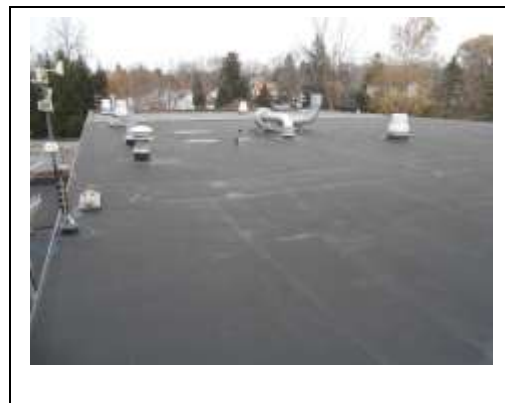
Observation #27 - This roof was wearing well and well adhered.

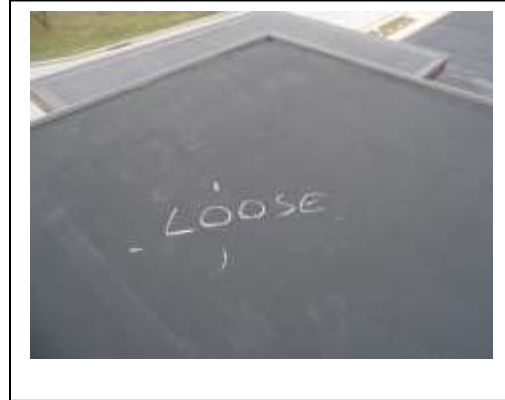
Observation #28 - The southwest corner of the roof was loose. The corners of roofs can receive more uplift stress from winds than other parts of the roof. This corner could be monitored to see if the condition worsens or simply re-adhered in the short-term.

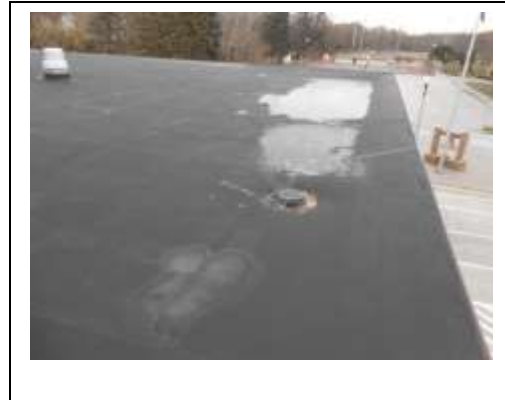
Observation #29 - Drainage was good with only minor ponding having been observed.

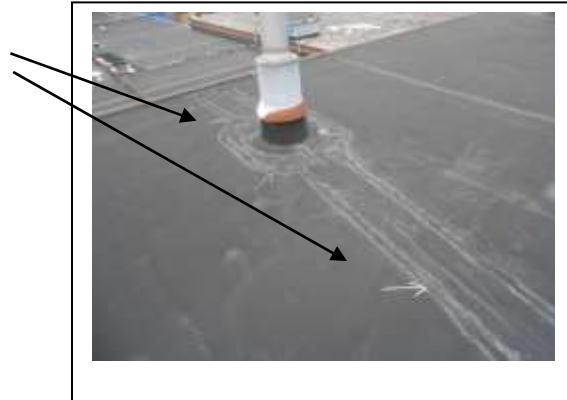
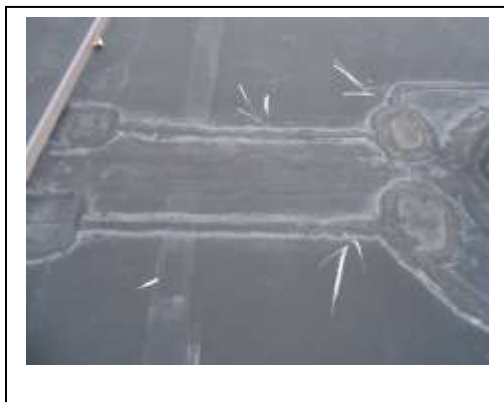
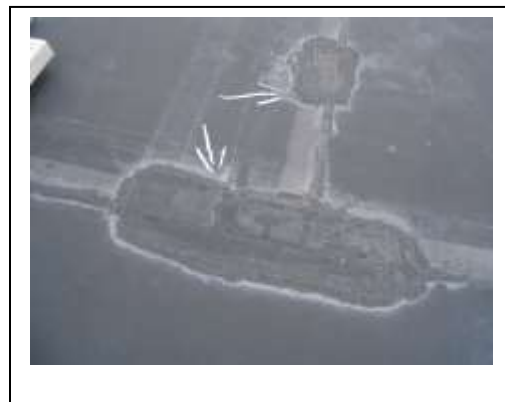
Observation #30 – Numerous repairs had been performed to some field seams and numerous T-joint patches and flashings.

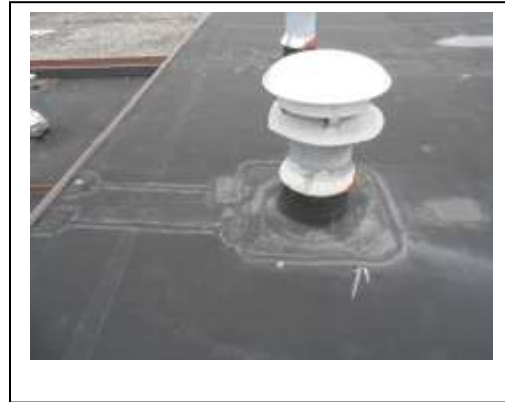
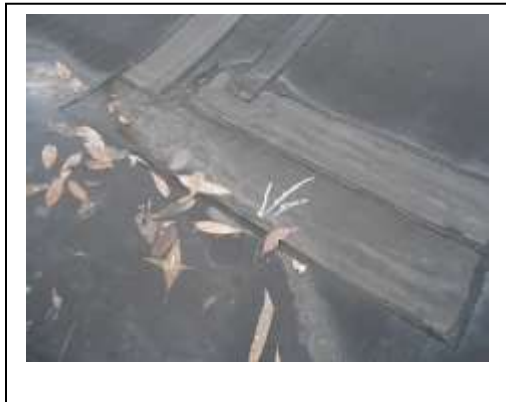
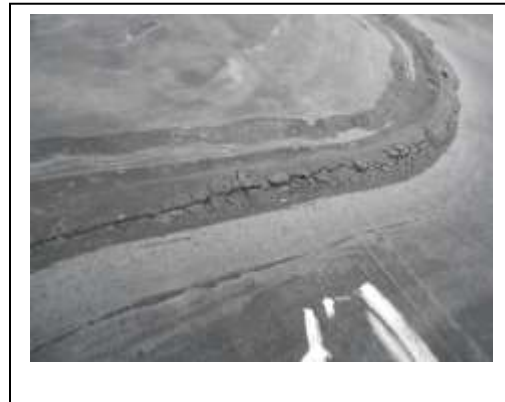
Observation #31 - Prior repairs had been performed to some of the various roof flashings. Re-caulking with lap sealant provided a short-term seal. Seams repaired with lap sealant only should be covered with cover tape for longer performance.

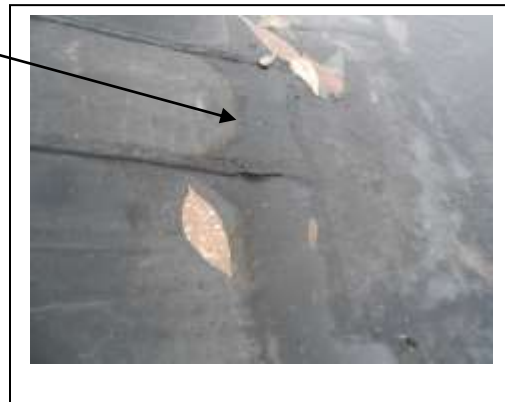
Observation #32 - The intersection of the south bay roof with the north bay roof had been repaired previously and required some additional repair.

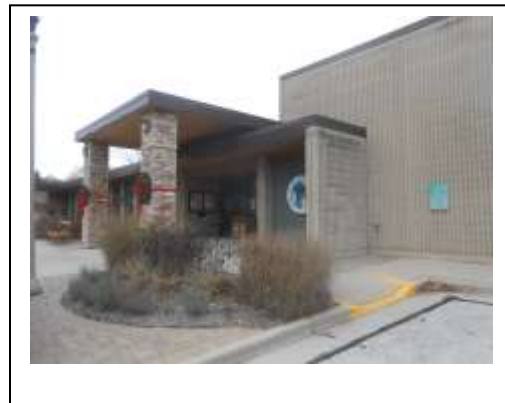
Observation #34 – The two southeast canopy roofs were new with the facade improvements several years ago.

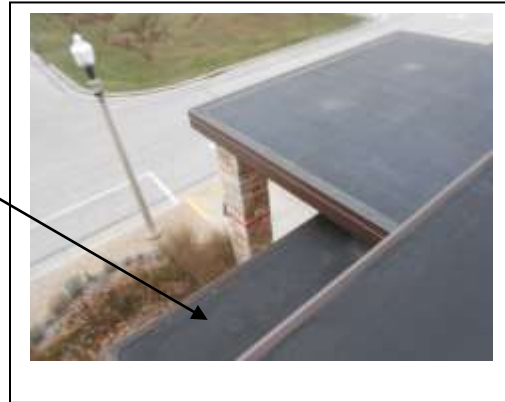
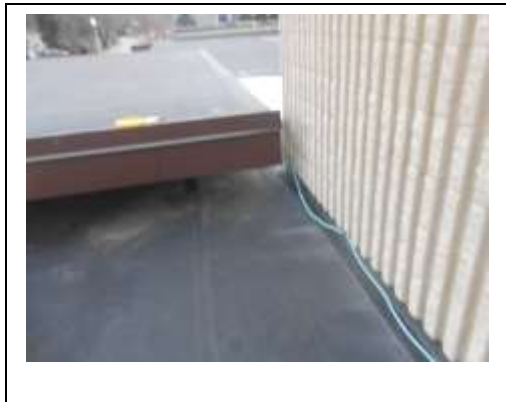
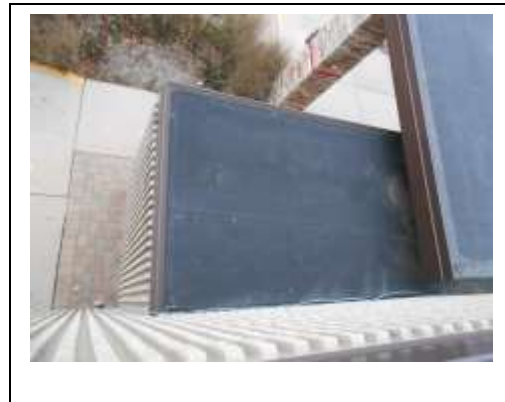
Observation #35 -The two southeast canopy roofs were fairly new and in very good condition.

The lower easts roof was well adhered and flashed well to the outer edges and adjacent South Apparatus Bay wall to the north.

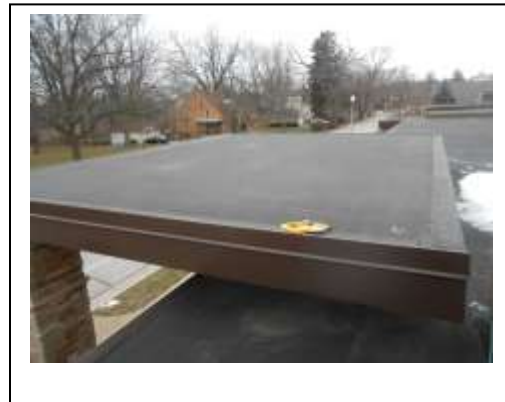
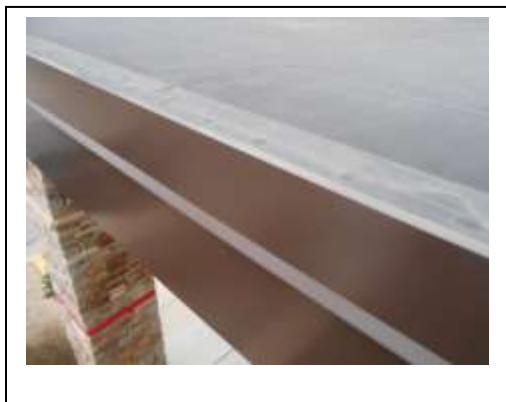
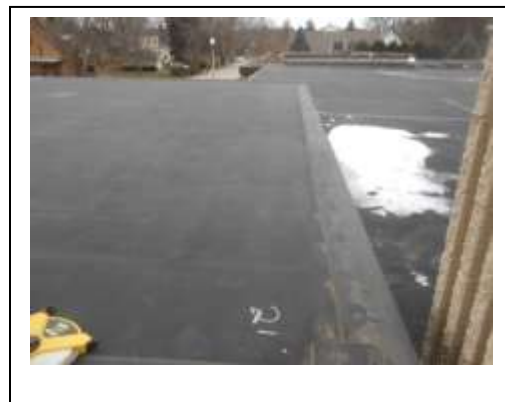
Observation #36 - The upper roof to the west was also well adhered, drained well and was flashed securely on all four edges.

No defects ere noted in the perimeter roof edge / fascia metal.

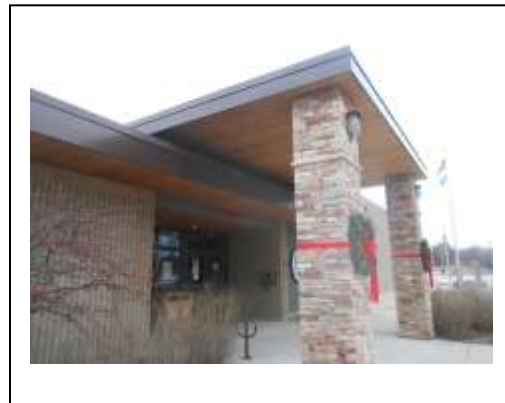
Observation #37 - The southwest canopy roof was new with the facade improvements several years ago.

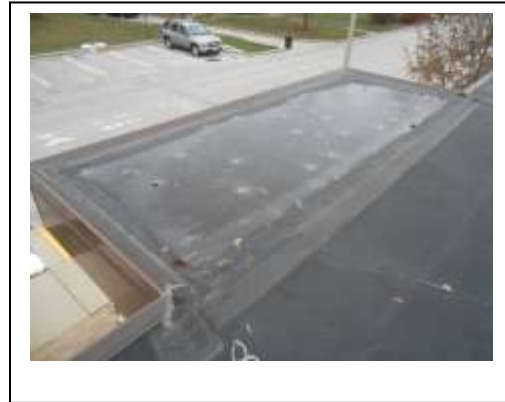
Observation #38 - The southwest canopy roof was well adhered and in very good condition.

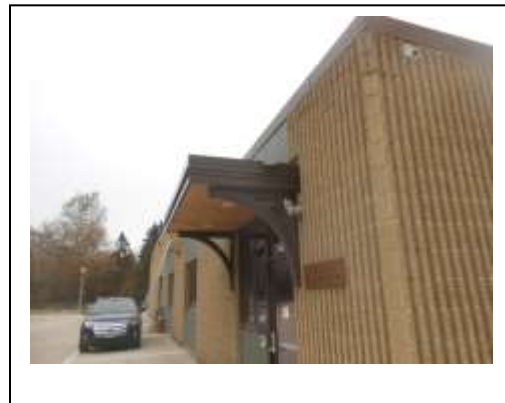
Observation #40 - The north canopy roof was new with the facade improvements several years ago.

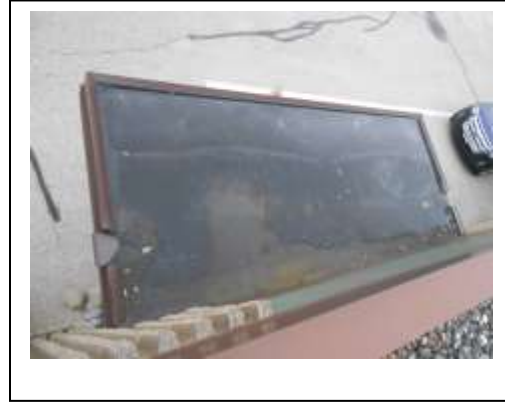
Observation #41 - The north canopy roof was well adhered, drained well and was in very good condition.

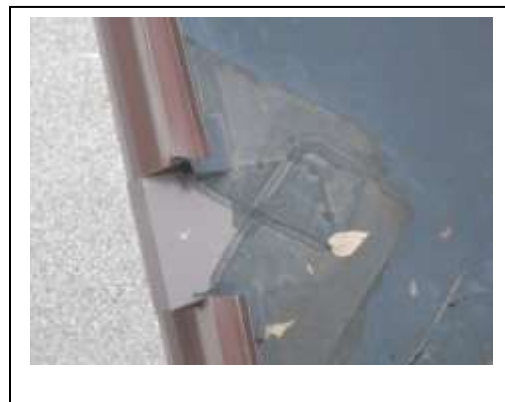
Observation #44 - The small drain scuppers appeared to be functioning well.
