Project: Village Hall Roof Assessments

Inspector: Ron Dorszynski
Date: 10/10/18 and 11/19/2018
Others Present: Andy LaFond and Diane Robertson

Roof ID: Village Hall Offices

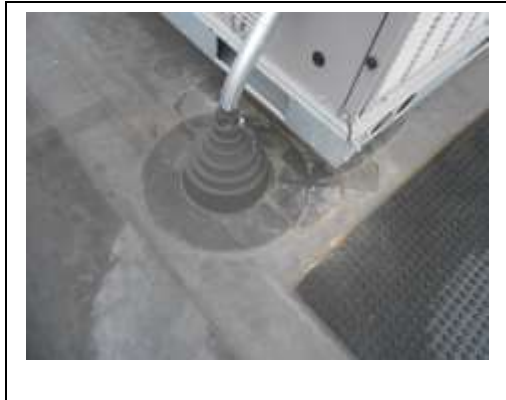
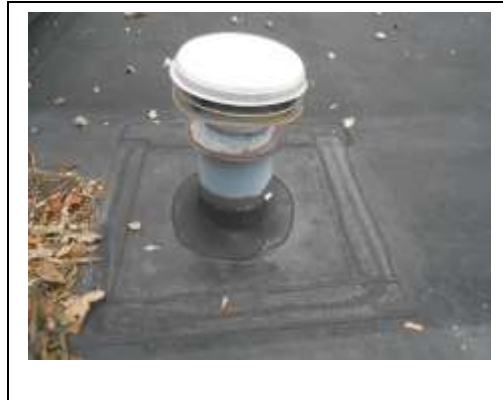
Observation #4 - Flashings around the various roof vents and rooftop units appeared fairly-sound.

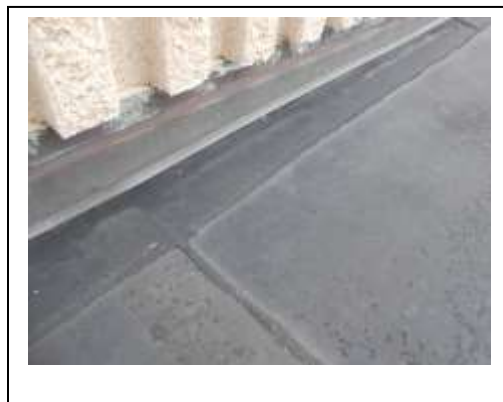
Observation #5 - Base and metal flashing components appeared fairly-sound around the roof edges.

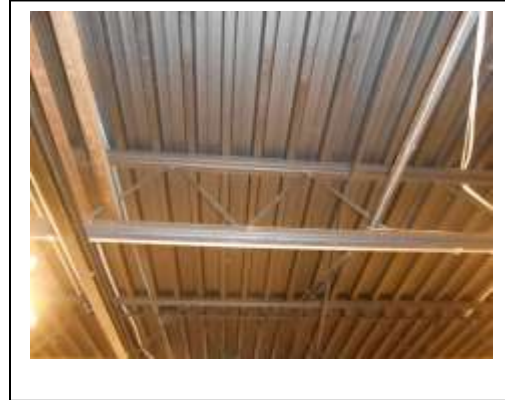
Observation #12 - The metal roof deck over steel trusses was typical construction on all the main roof areas.

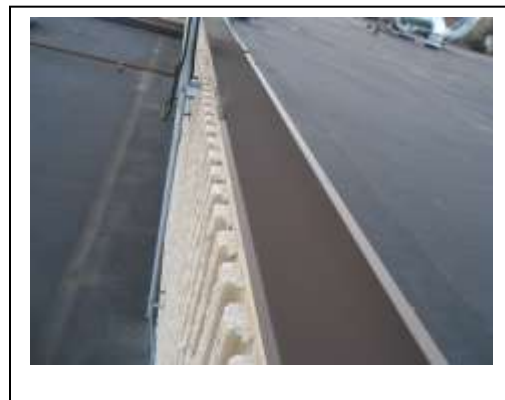
Observation #33 - The metal roof edge components appeared sound.

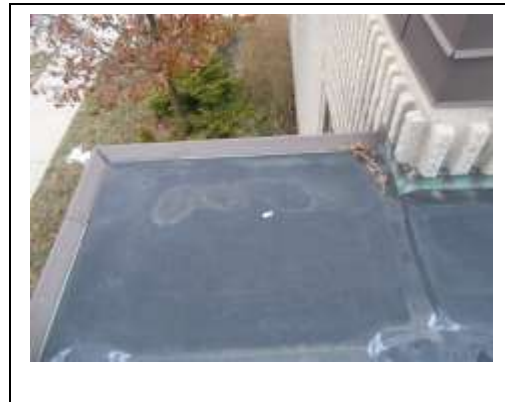
Observation #39 - The perimeter edges were sealed well to the outer roof edge metal, the board room sidewall and the adjacent Village Hall roof.

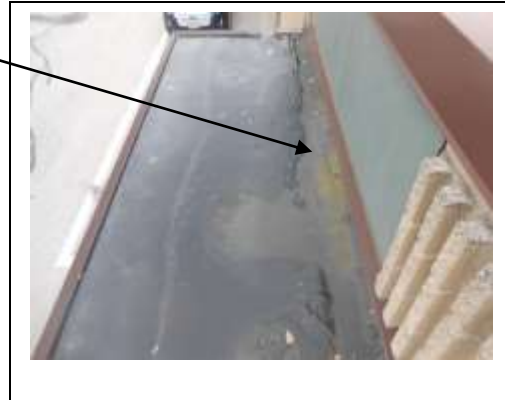
Observation #42 - The south base flashing and metal counter flashing on the sidewall appeared sound.

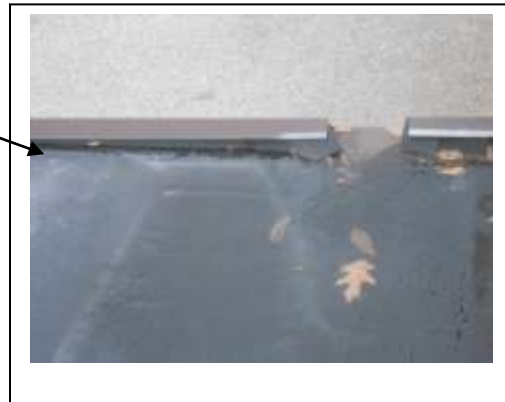
Observation #43 - The membrane was sealed well at the low-profile metal outer roof edge flashing.
